Preliminary Assessment

Site: Komag 4
275 South Hillview Drive
Milpitas, CA 95035
Santa Clara County

Date: January 20, 1992

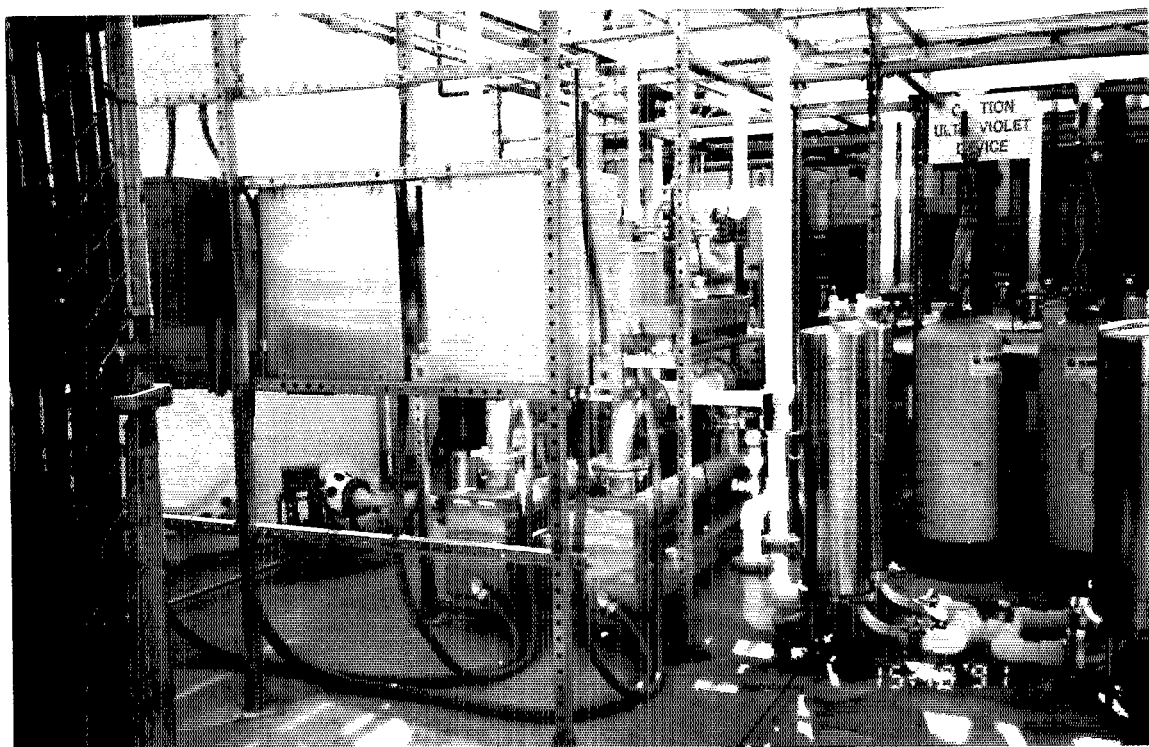
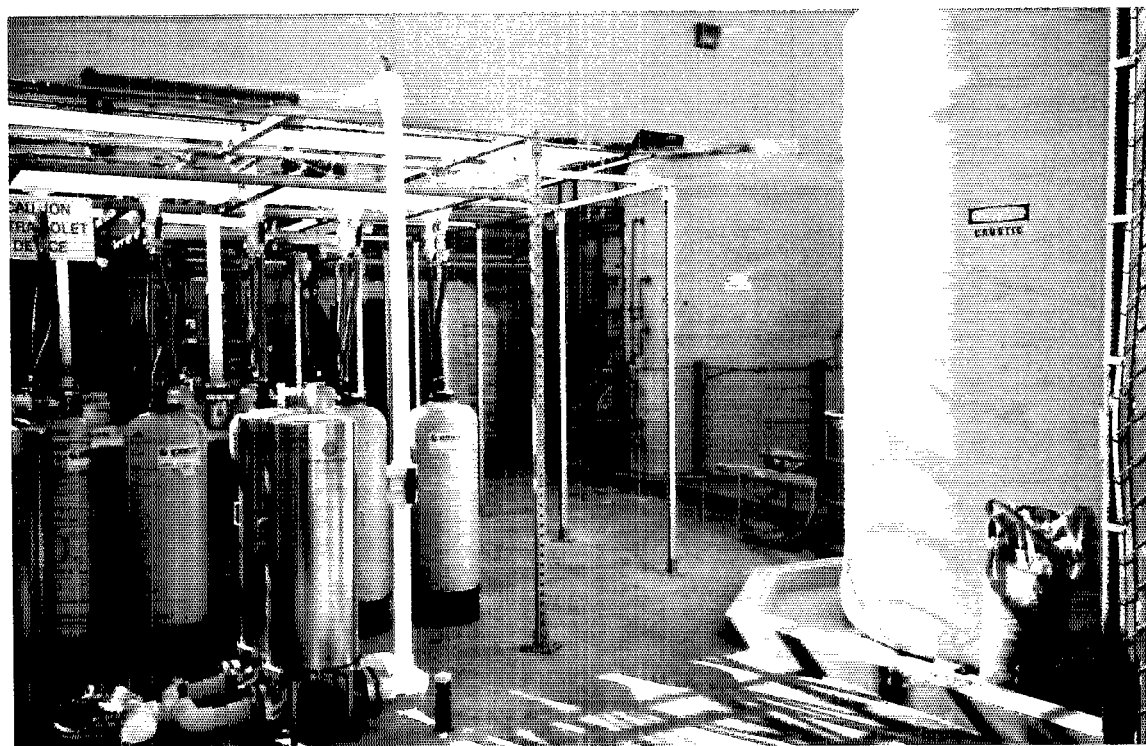
5. Komag 4 De-ionizing Water System, located at the northern side of the building

6. Komag 4 De-ionizing Water System, located at the northern side of the building

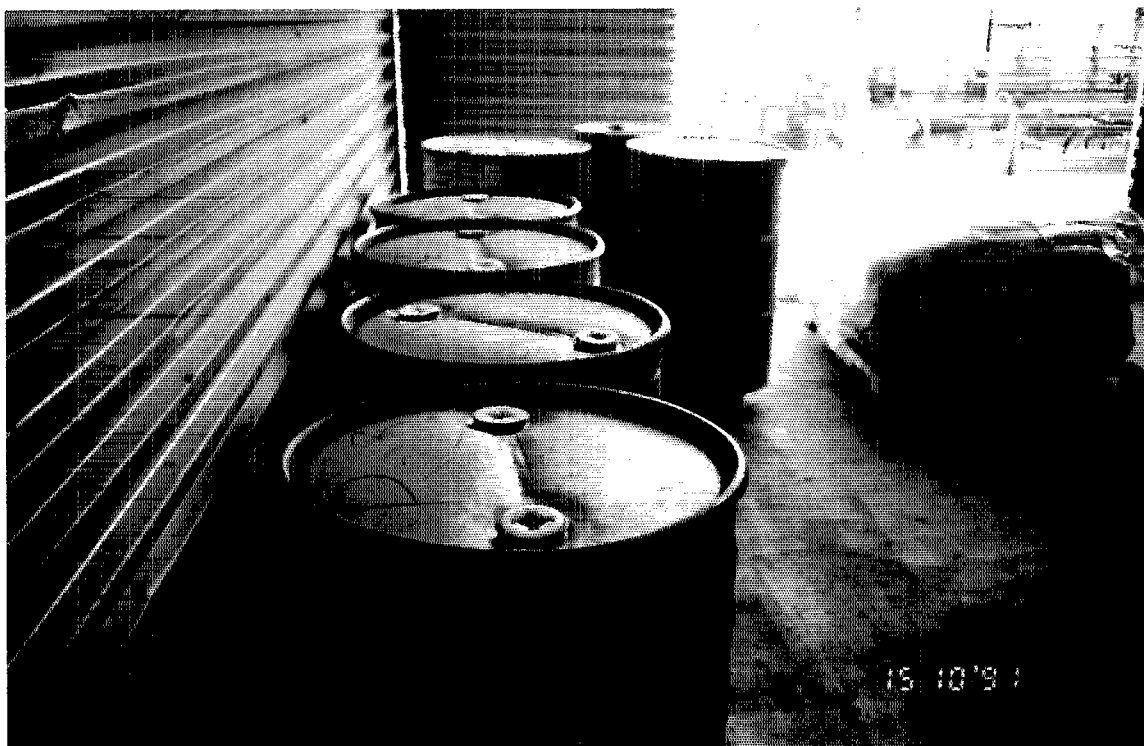
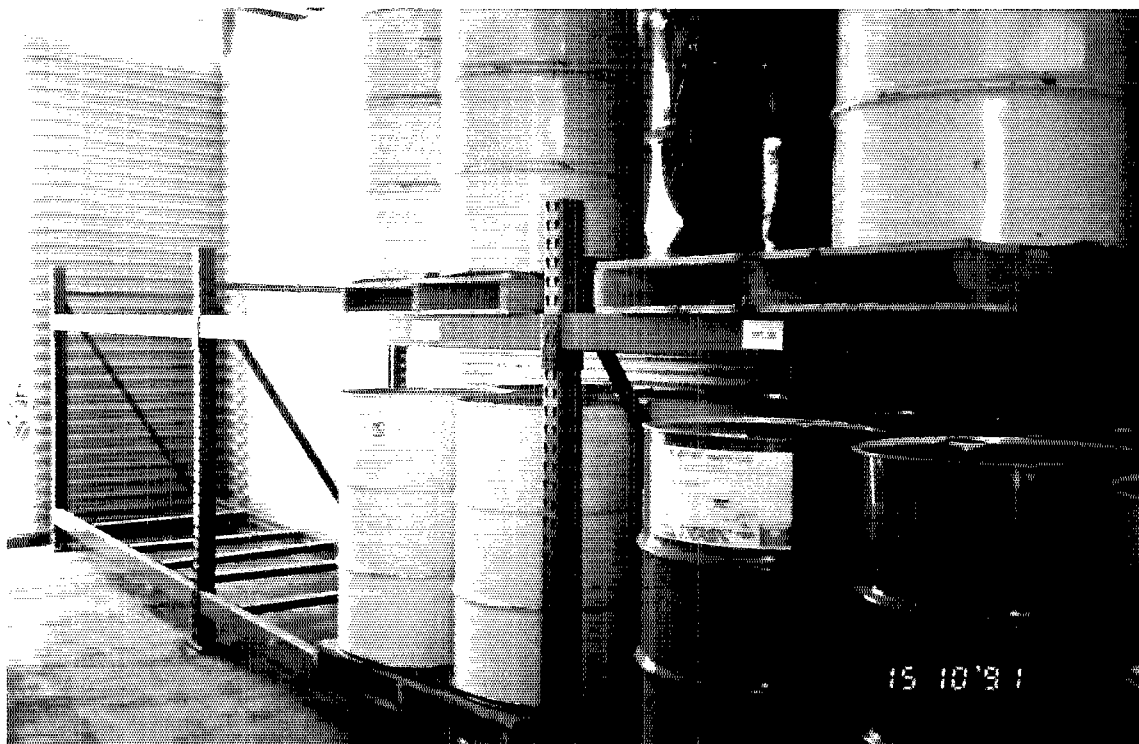
Komag, Inc. stores both raw materials and hazardous wastes in this area. Hazardous wastes are mostly spent nickel and zinc solutions, and are stored in 55-gallon drums. According to Komag's Hazardous Materials Business Plan, a maximum of 40 drums of hazardous wastes and 190 drums of raw materials are stored in this area.

The pavement of the inside chemical storage area is stained, which suggests that chemical spills have occurred in the past. However, any spilled chemical will have a low probability of escaping this storage area.

7. Inside Chemical Storage Area. Komag stores both raw materials and hazardous wastes in this area. Hazardous wastes include spent nickel and zinc solutions

8. Inside Chemical Storage Area. Komag stores both raw materials and hazardous wastes in this area. Hazardous wastes include spent nickel and zinc solutions

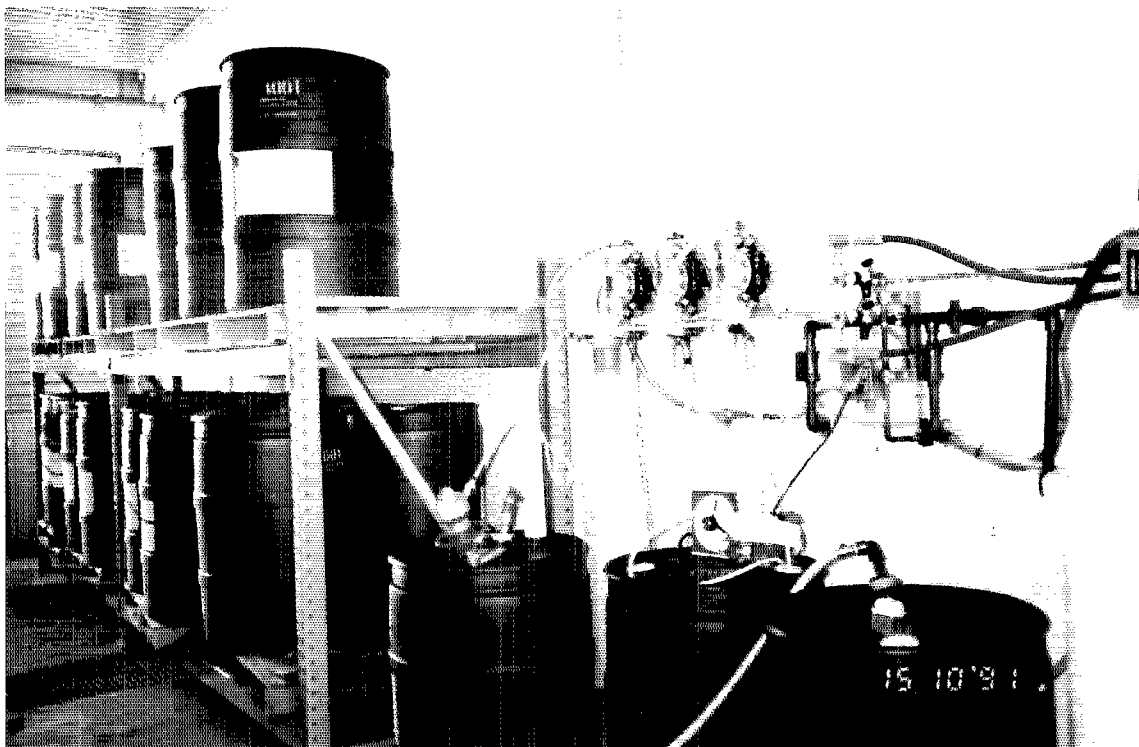
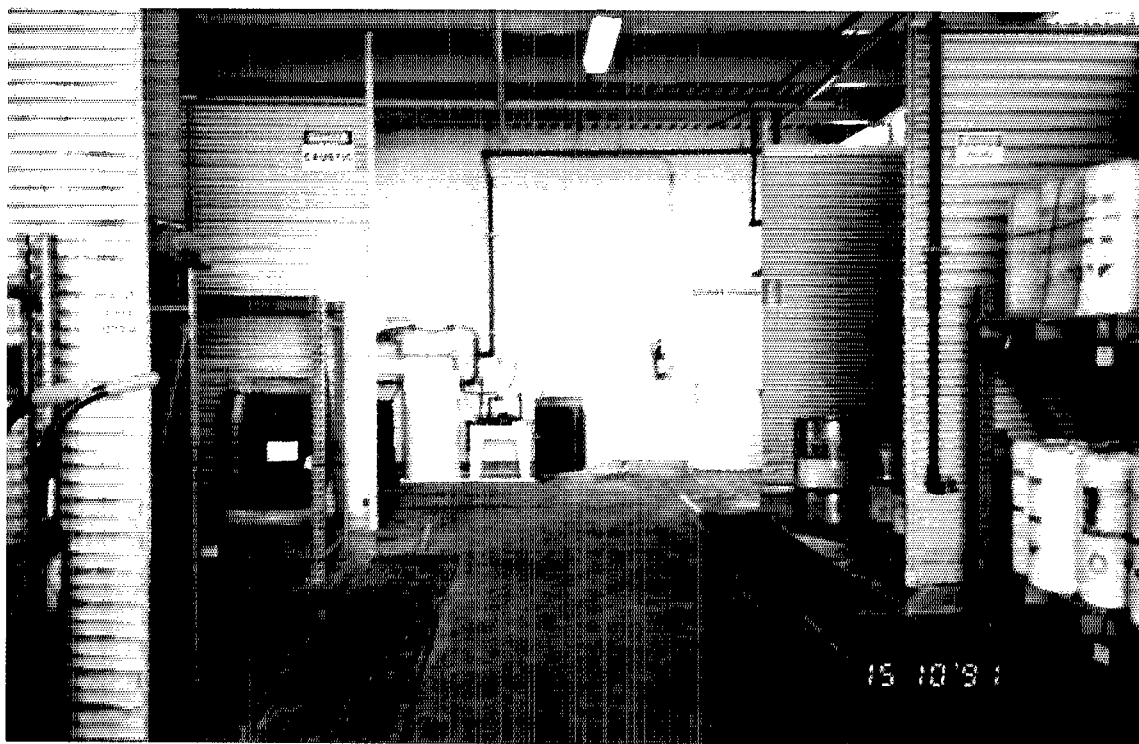
9. Inside Chemical Storage Area. Notice the drainage system surrounding this area

10. Inside Chemical Storage Area. Notice the drainage system surrounding this area

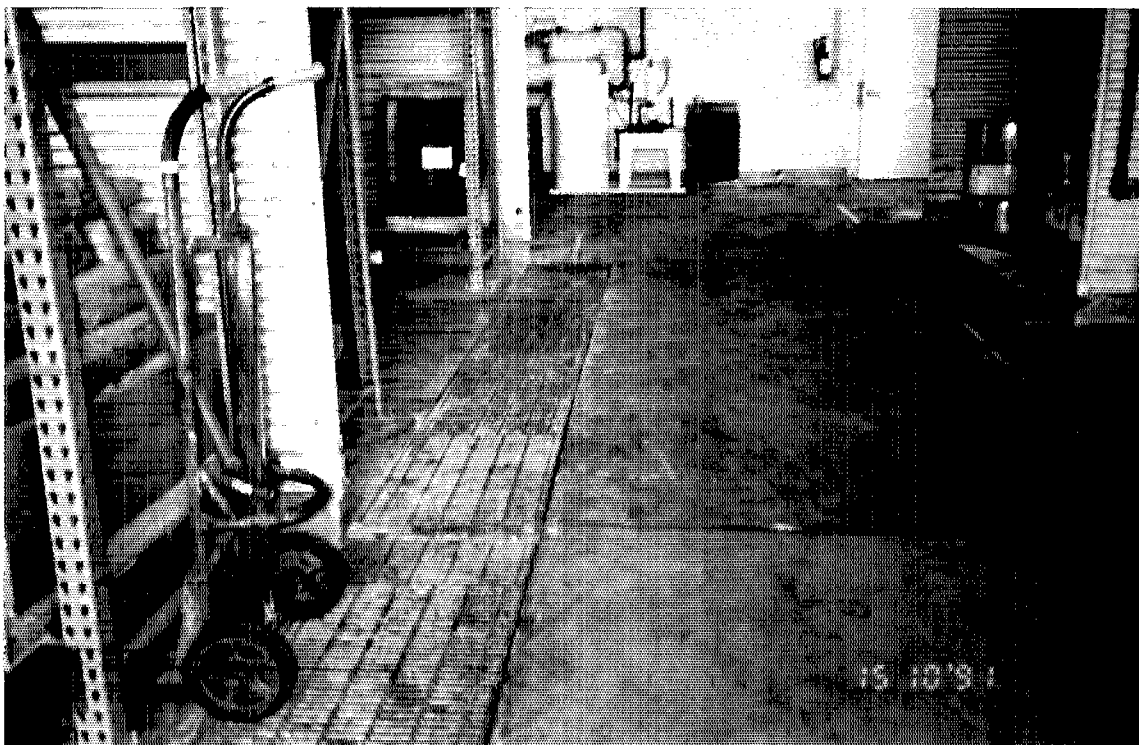
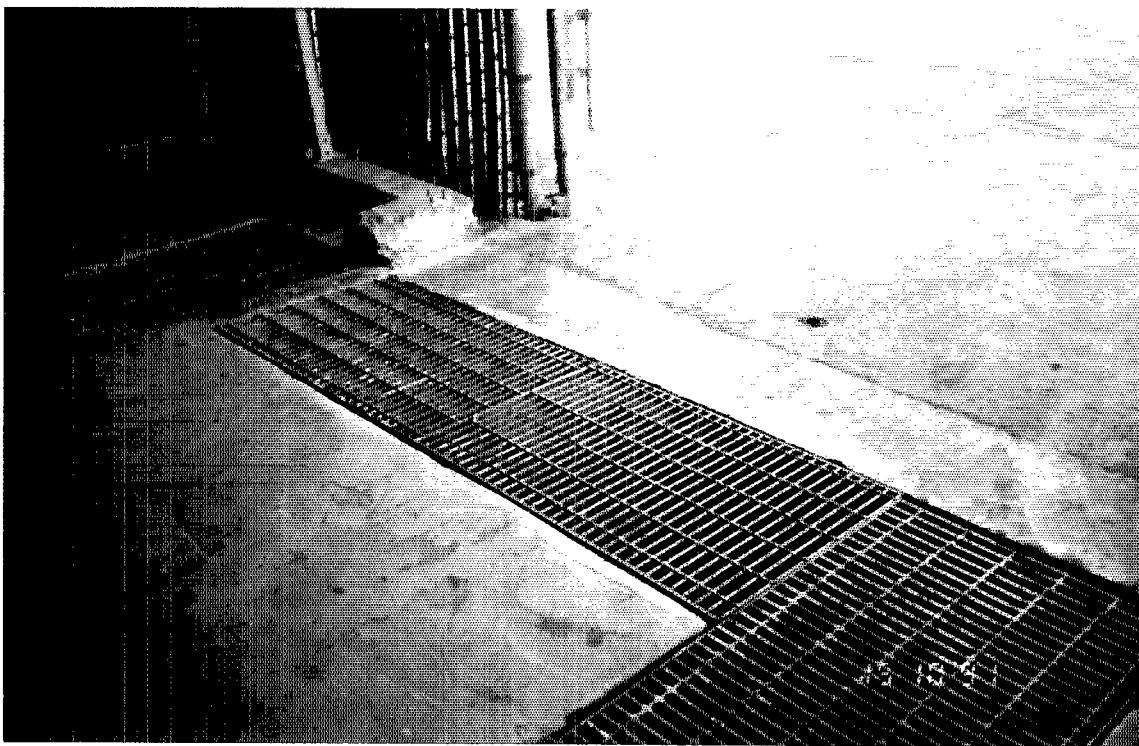
11. A closer look at the drainage system

12. A closer look at the drainage system (notice the berm)

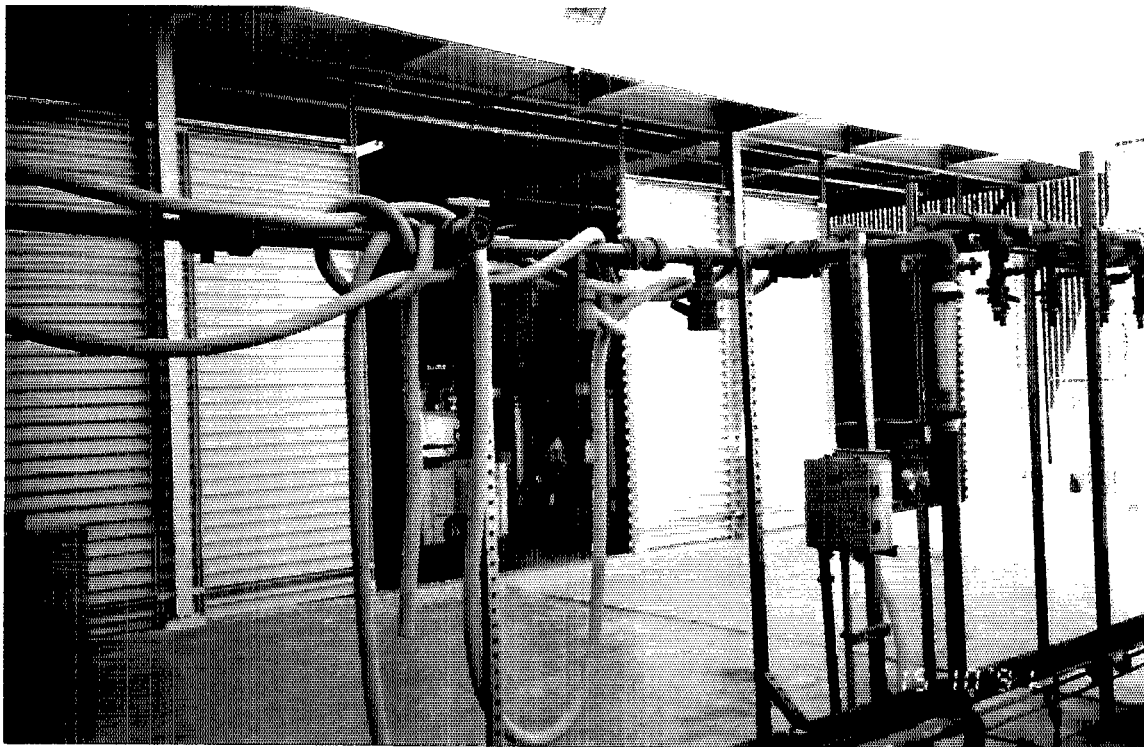
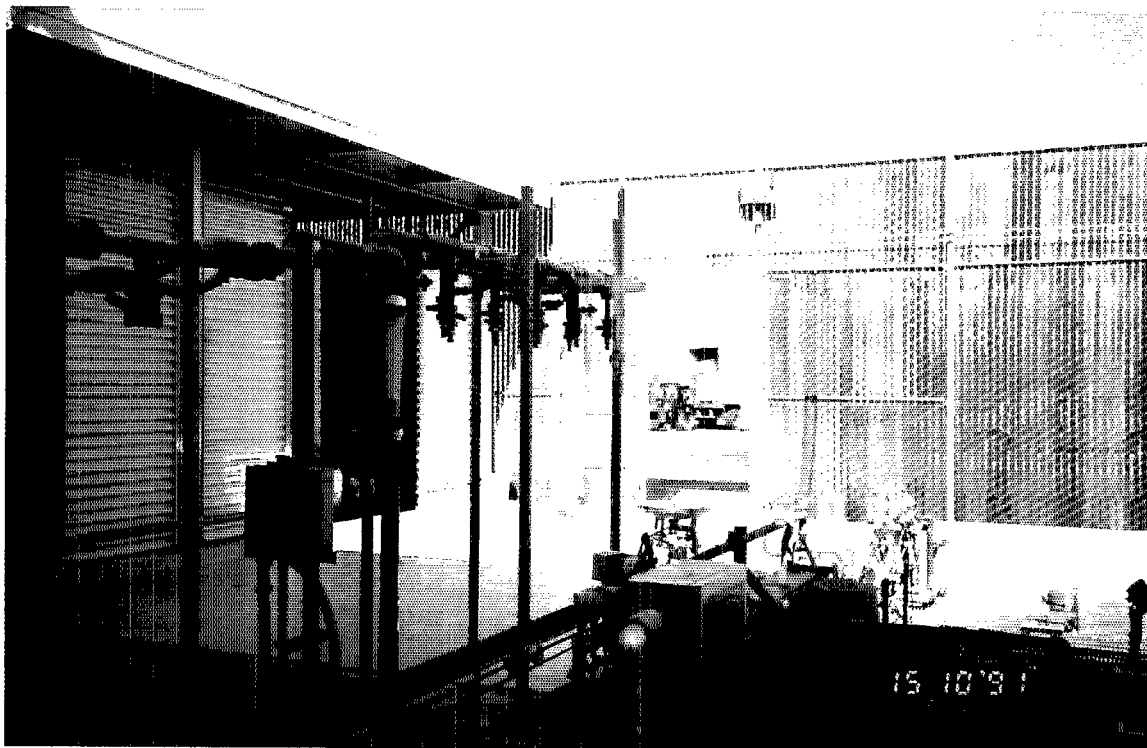
13. View of the Inside Chemical Storage Area from the Wastewater Treatment System Area

14. View of the Inside Chemical Storage Area from the Wastewater Treatment System Area

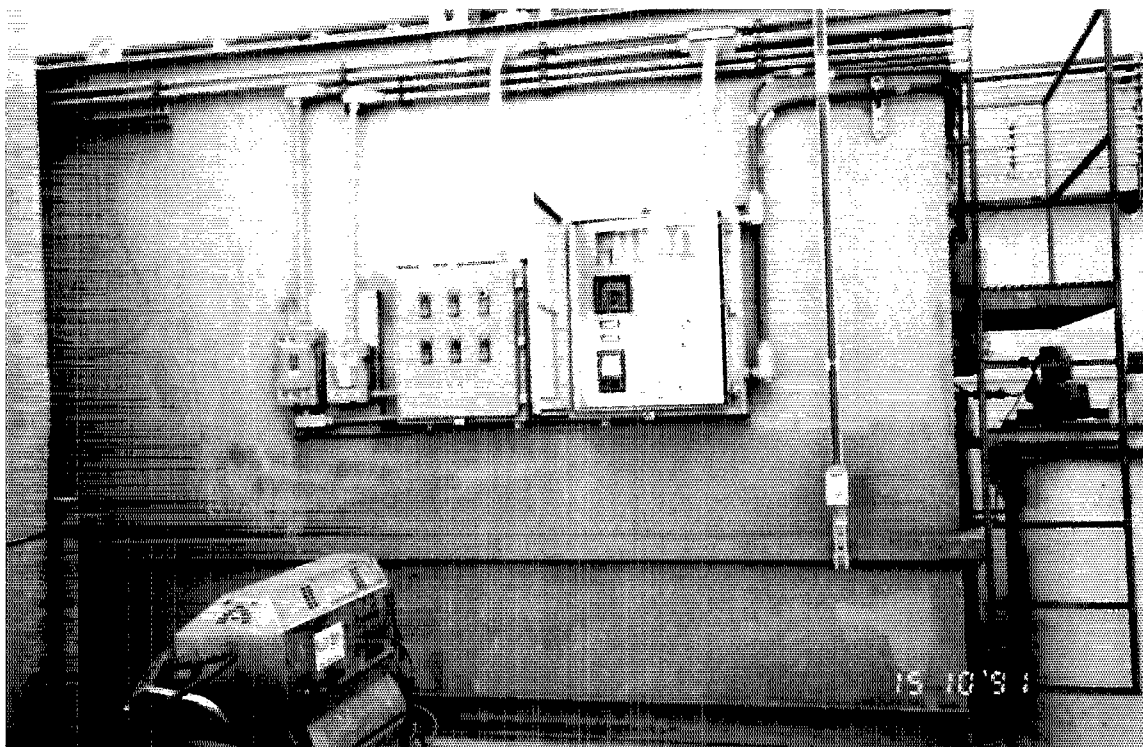
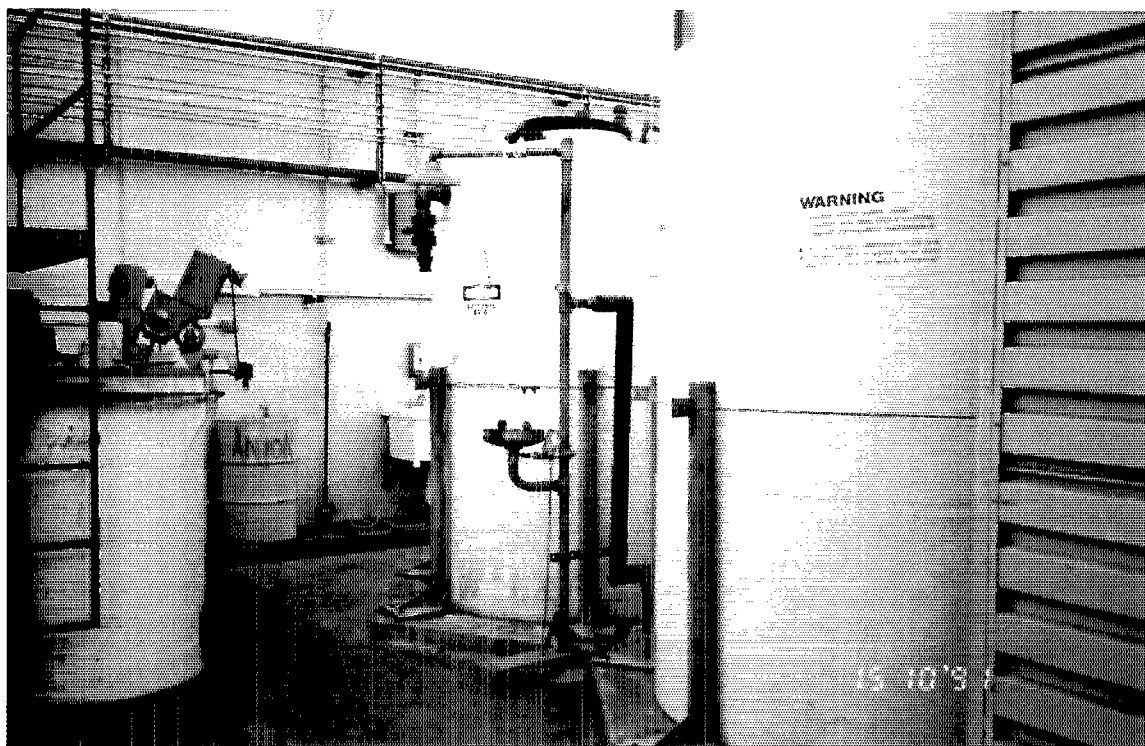
There are eleven above-ground and seven underground storage tanks located inside the wastewater treatment system area. These tanks contain raw materials and non-hazardous and hazardous wastes. The underground storage tanks are located inside an epoxy-coated concrete vault, which acts as a secondary containment. There have been no reported leaks from the above-ground and underground tanks.

15. The Wastewater Treatment System and above-ground storage tanks in the Wastewater Treatment System Area

16. The Wastewater Treatment System and above-ground storage tanks in the Wastewater Treatment System Area

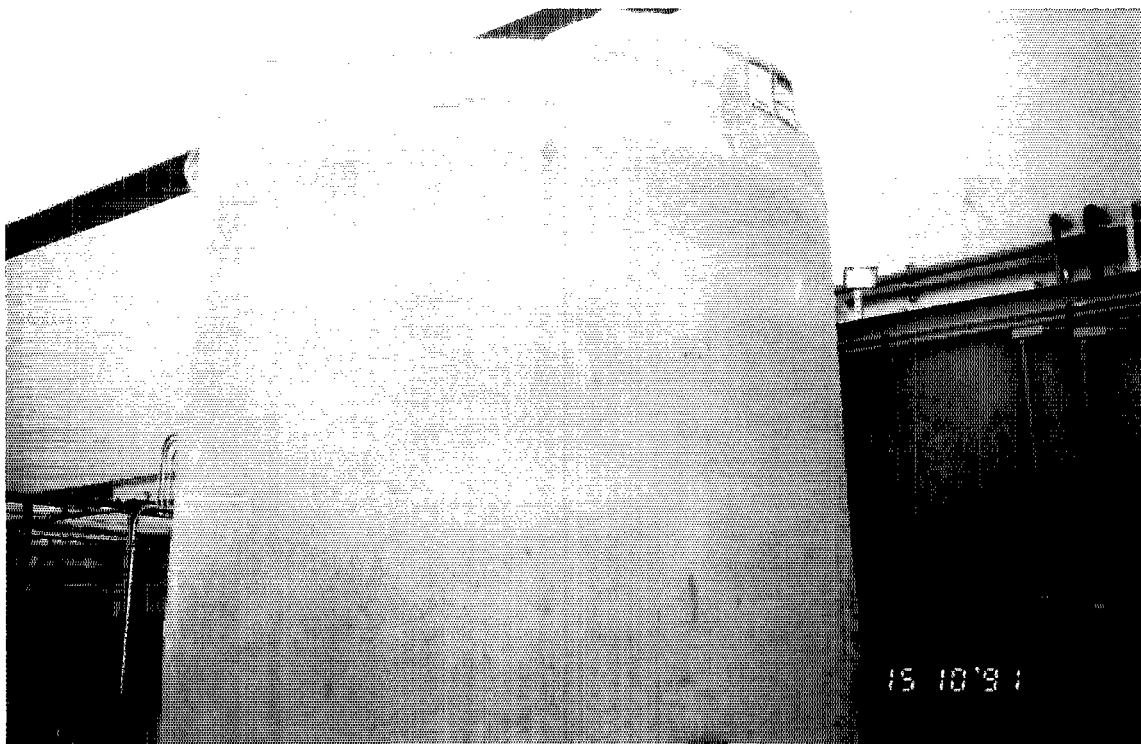
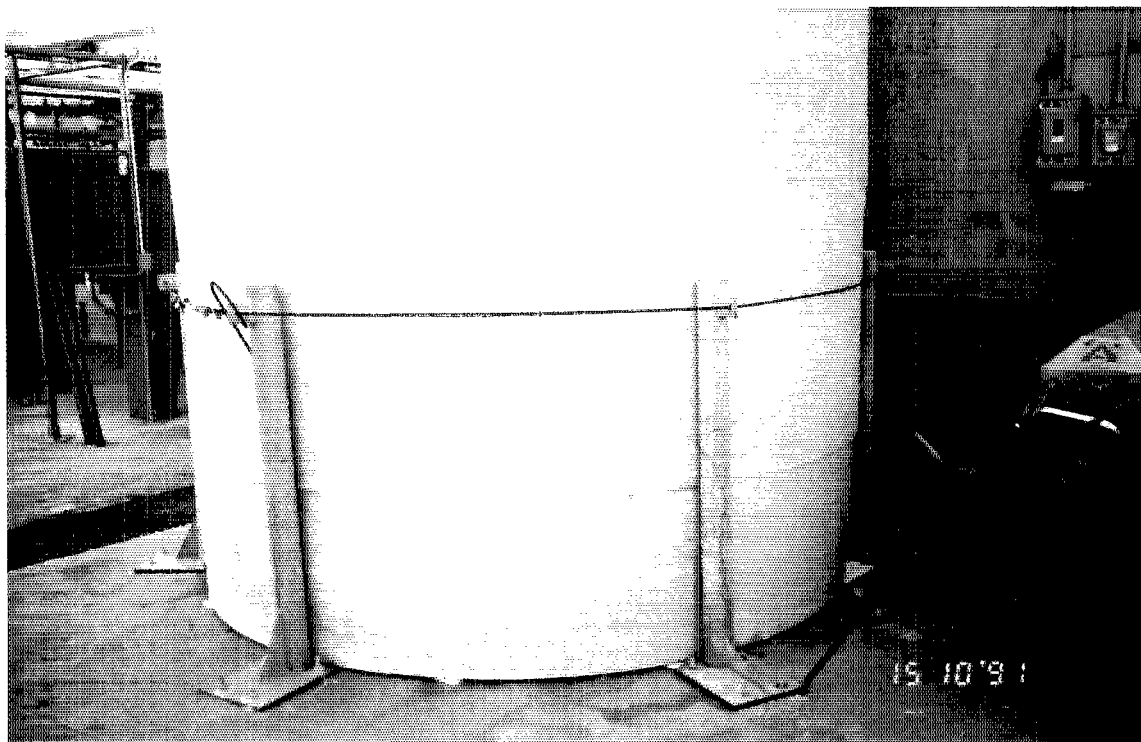
17. Above-ground storage tank containing sludge materials

18. Above-ground storage tank containing sludge materials

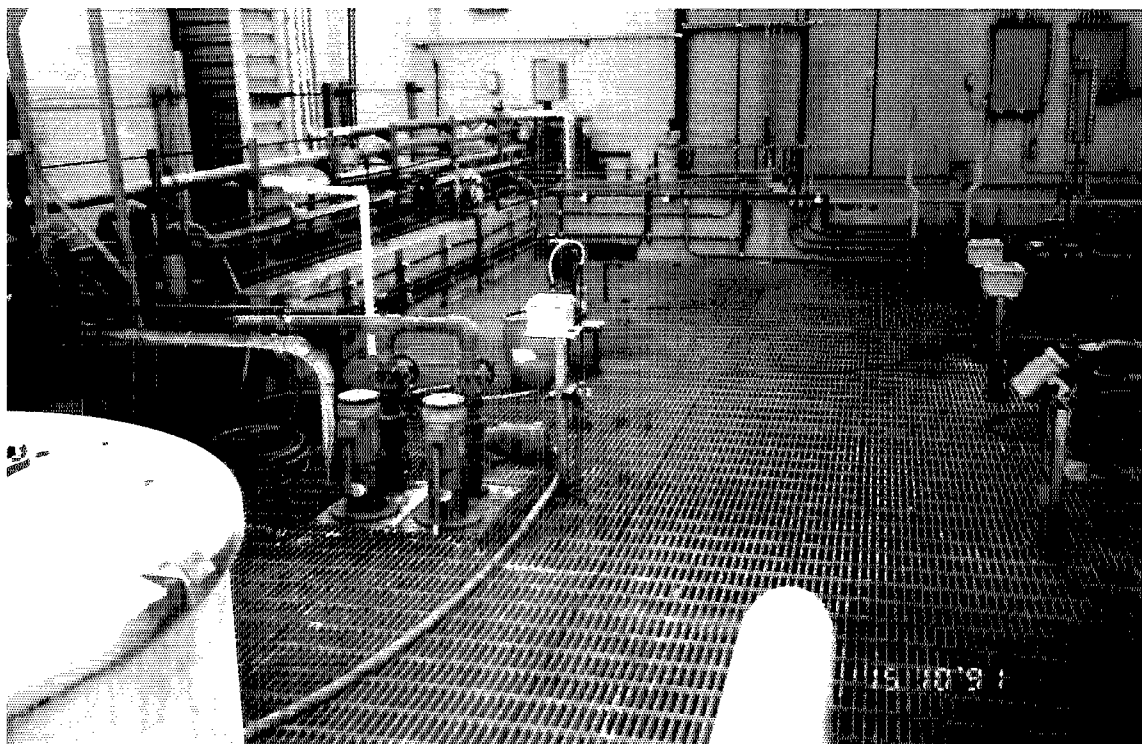
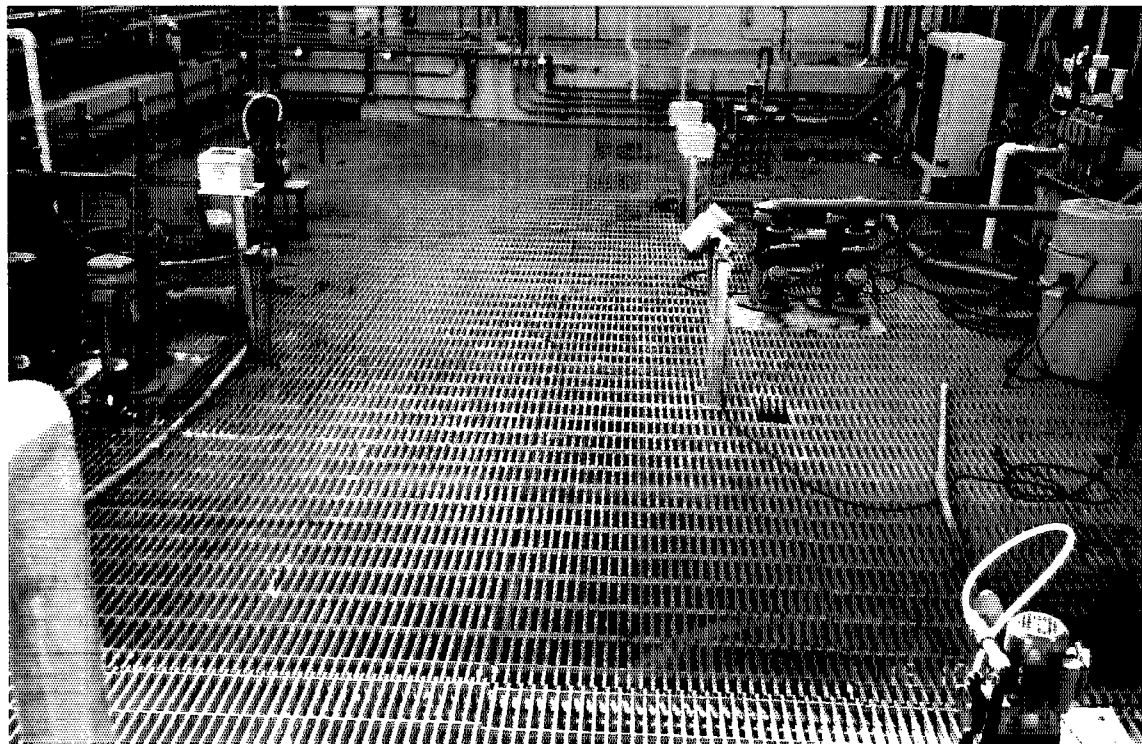
19. View of the epoxy-coated, concrete vault containing several underground storage tanks, located in the Wastewater Treatment System Area

20. View of the epoxy-coated, concrete vault containing several underground storage tanks, located in the Wastewater Treatment System Area

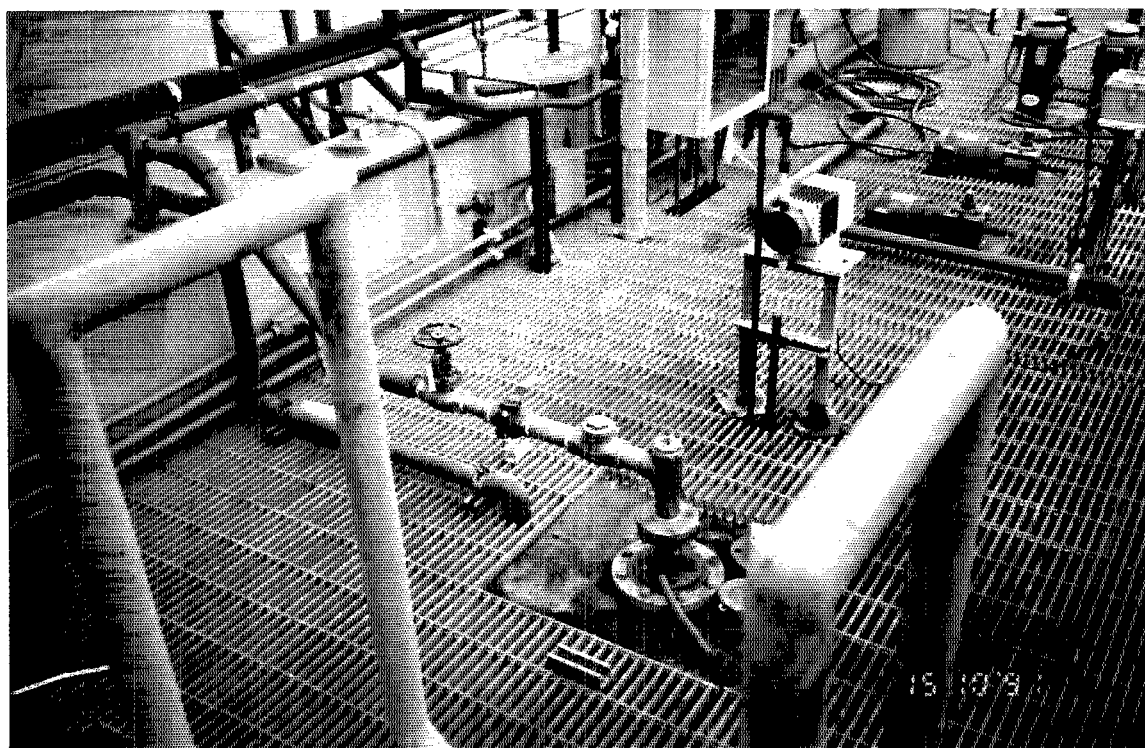
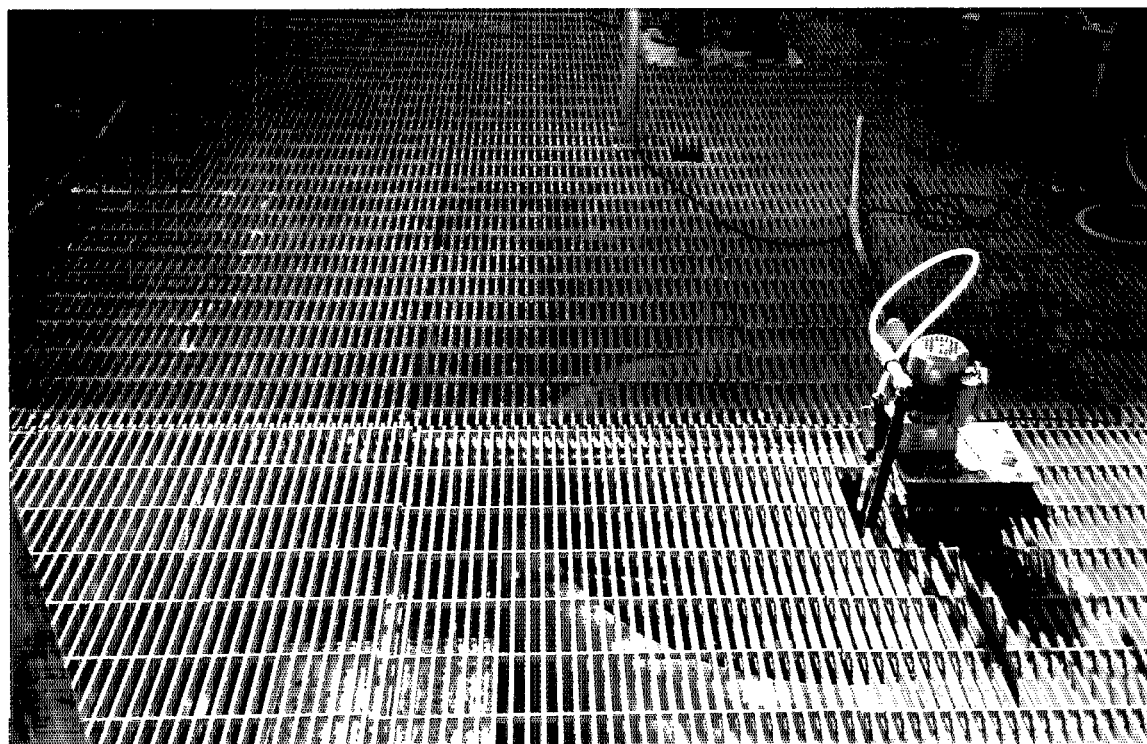
21. Close-up view of the concrete vault

22. Close-up view of the concrete vault

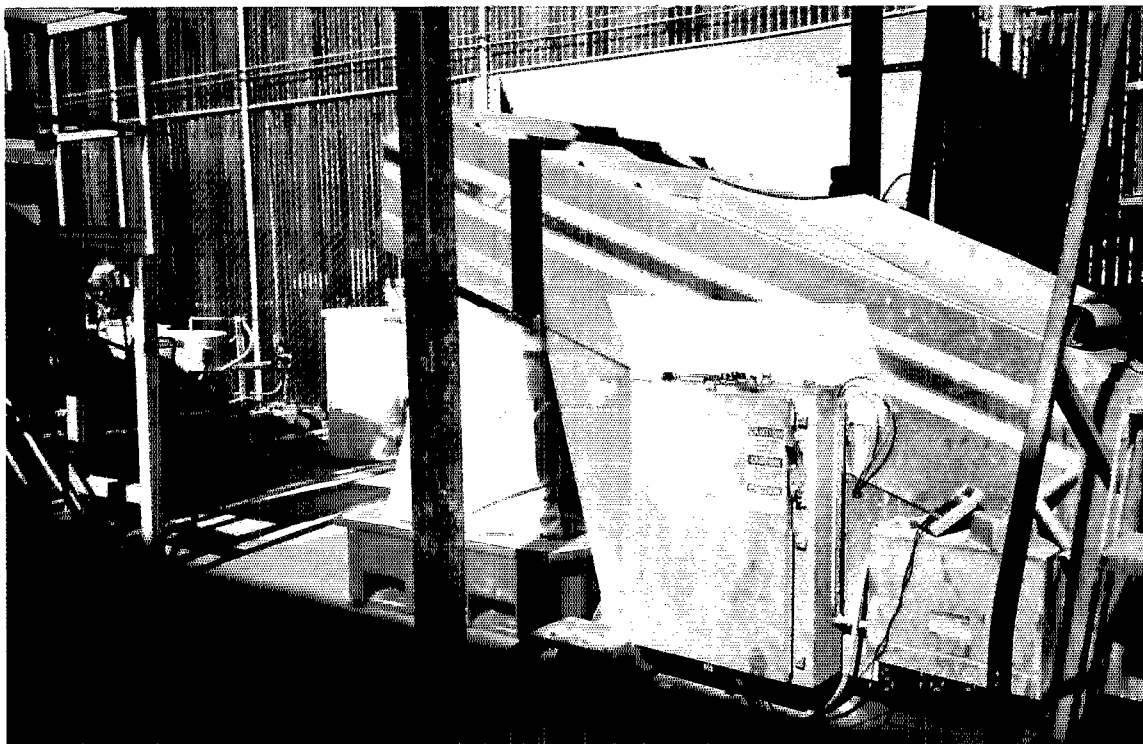
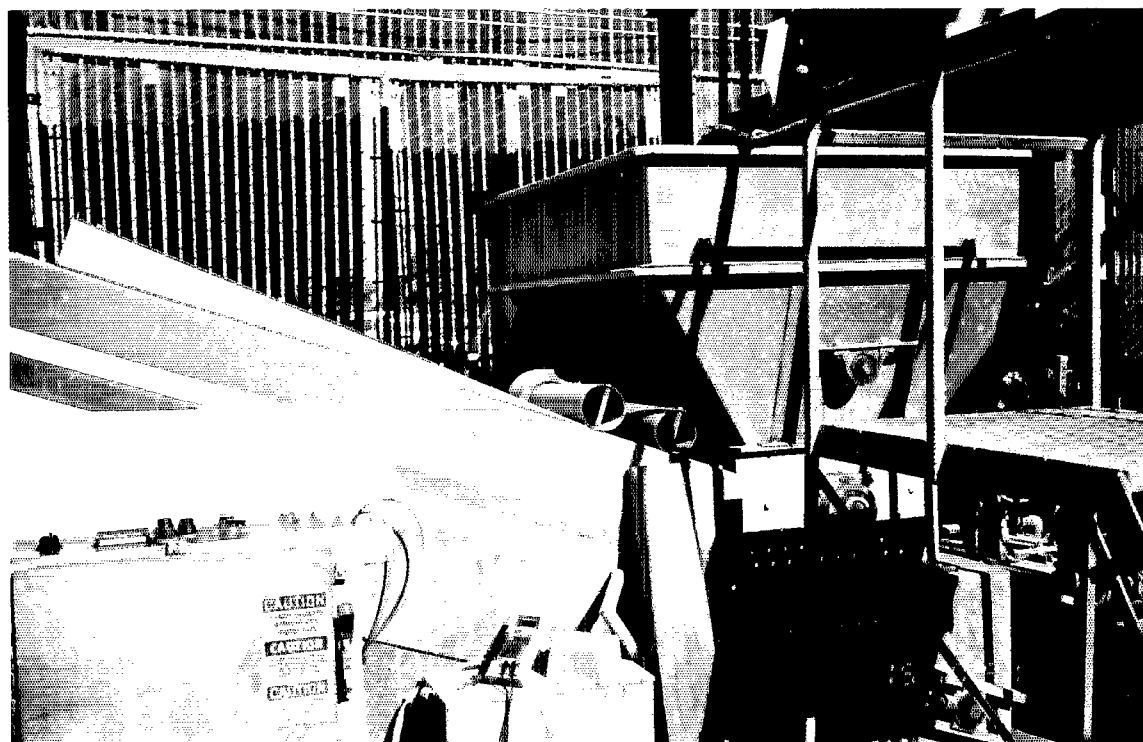
A sludge filter press is located near the entrance of this area. Sludge generated by the treatment system is transferred into nylon bags, and stored in roll-off bins. The sludge contains various precipitated metals such as nickel and zinc, and is considered hazardous. Komag 4 produces roughly 9.4 tons of sludge per month.

23. Komag 4's sludge filter press, located near the entrance of the Wastewater Treatment System Area

24. Komag 4's sludge filter press, located near the entrance of the Wastewater Treatment System Area

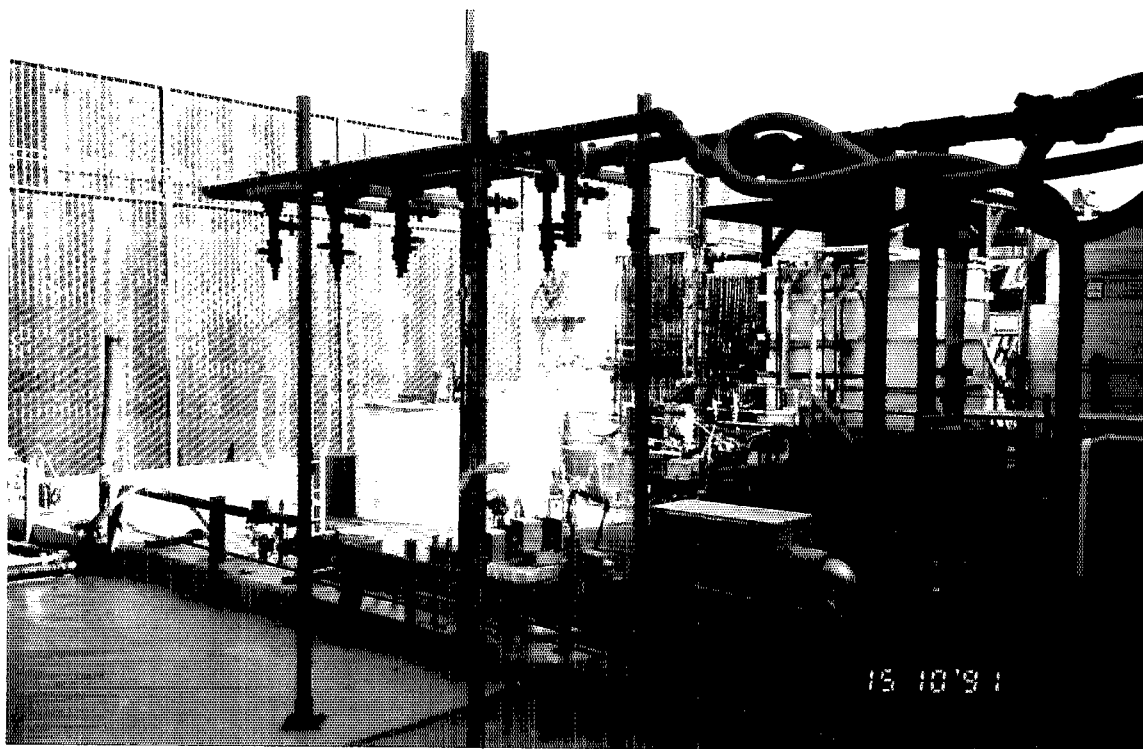
Stained areas of pavement are present within the wastewater treatment system area. Because this area is surrounded by berms and a drainage system, the likelihood of hazardous substances migrating outside of the area appears to be low.

25. A picture of the Wastewater Treatment System Area from the Inside Chemical Storage Area

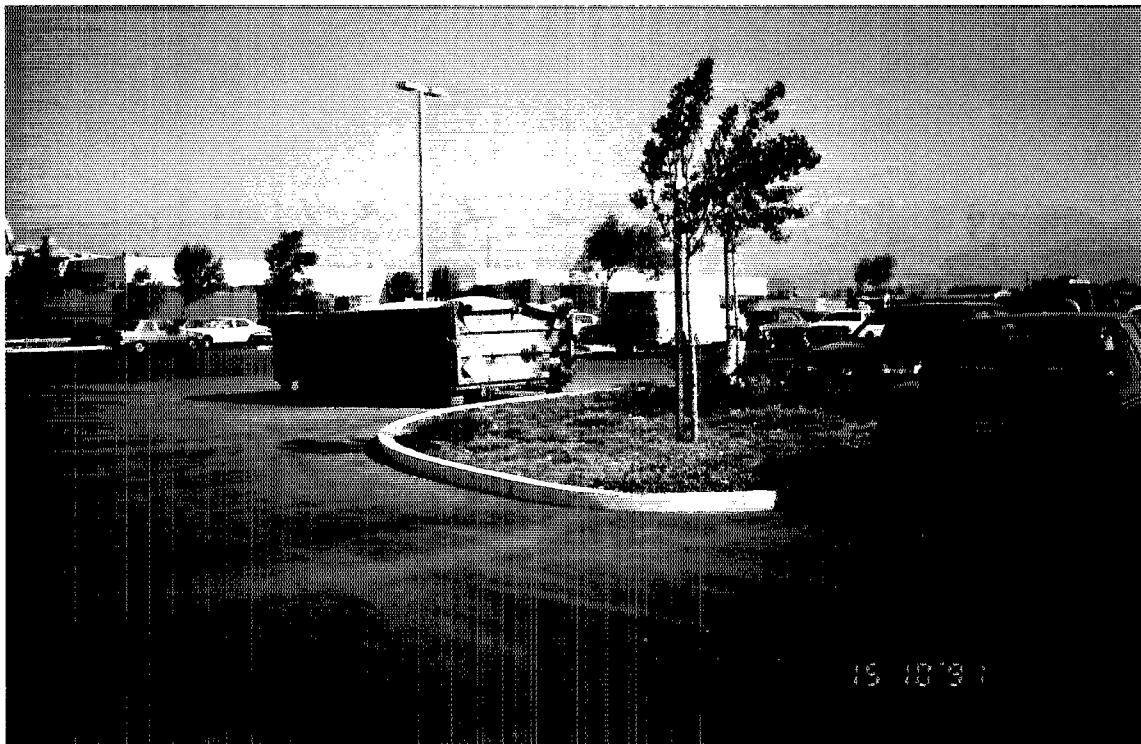
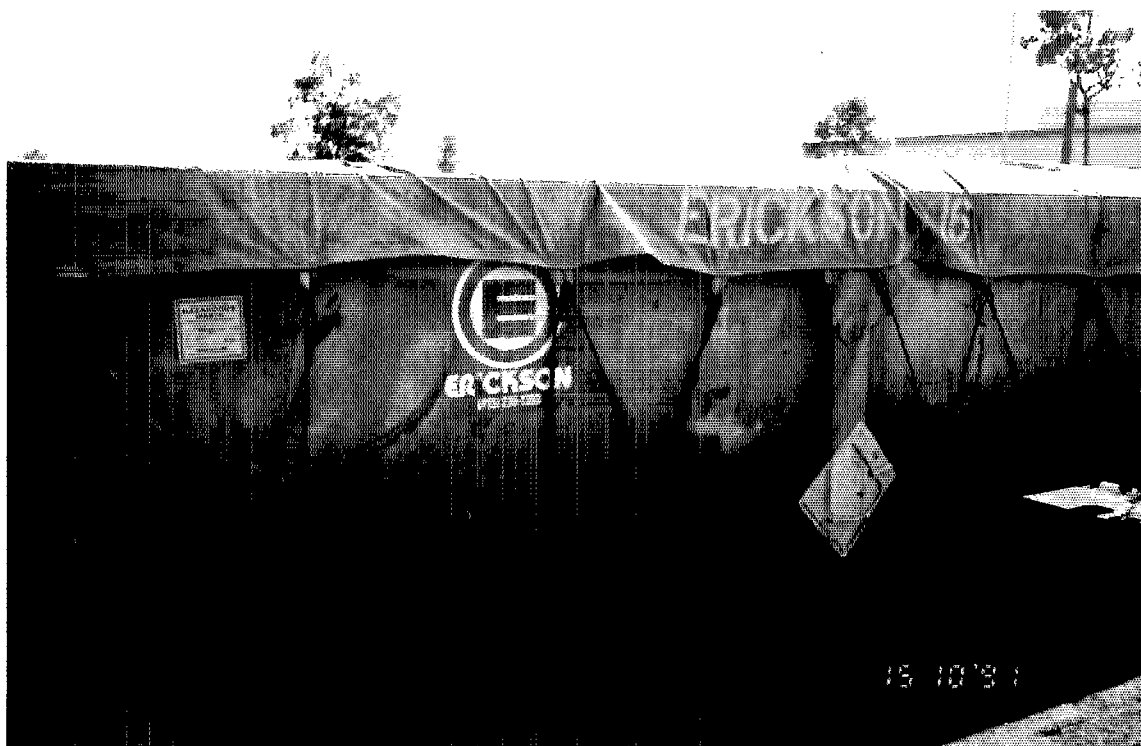
One 15-ton roll-off bin is located in the parking lot at the northern side of the site. Komag's representatives stated that there are usually two 15-ton roll-off bins in this area. Twenty-five tons of non-RCRA hazardous sludge from Komag 2, 4, and 6 are stored in these bins prior to pick-up for disposal. One-third of the sludge is from Komag 4's processes. Mr. Reposa stated that the bins are picked up by Exceltrans every month, and transported to an approved disposal site (USPCI).

26. One of Komag's 4's roll-off bins, located in the northern parking lot. According to Komag's representatives, there are usually two bins located here

27. One of Komag's 4's roll-off bins, located in the northern parking lot. According to Komag's representatives, there are usually two bins located here
